BARRINGTON TOWN-WIDE COMMUNITY FACILITIES STUDY

Final Report:
May 21, 2009

Prepared for:
Town of Barrington
Rhode Island

Prepared by:
Graham/Meus Inc. Architects
Six Edgerly Place
Boston, Massachusetts 02116

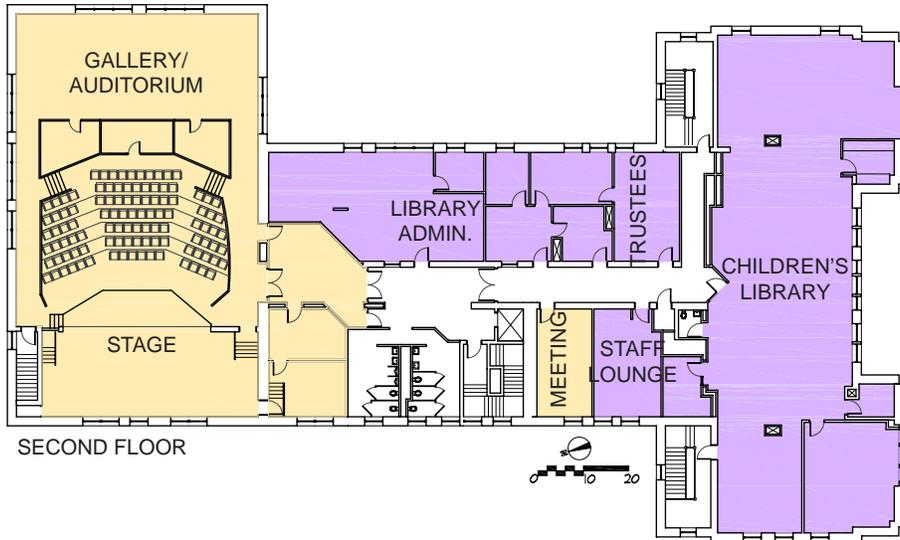
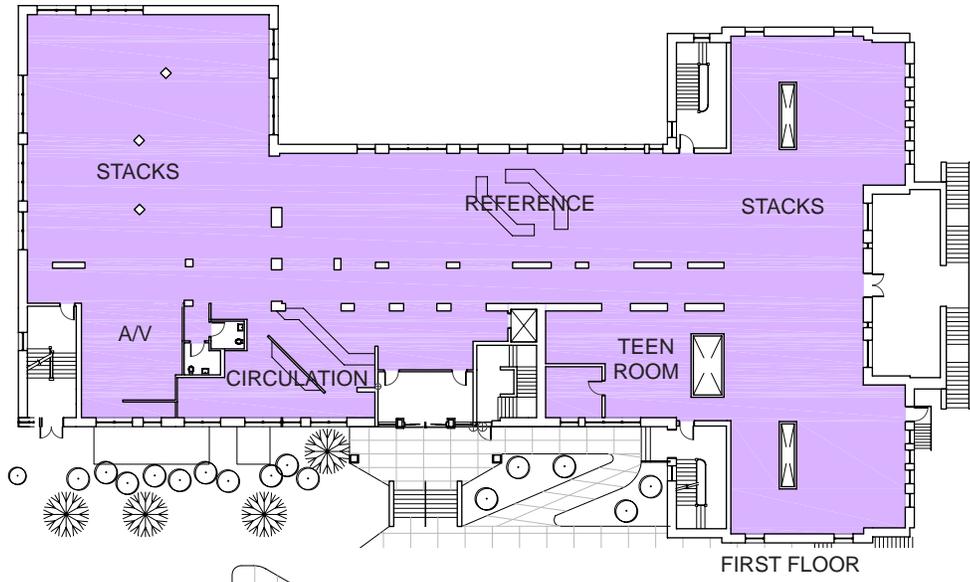
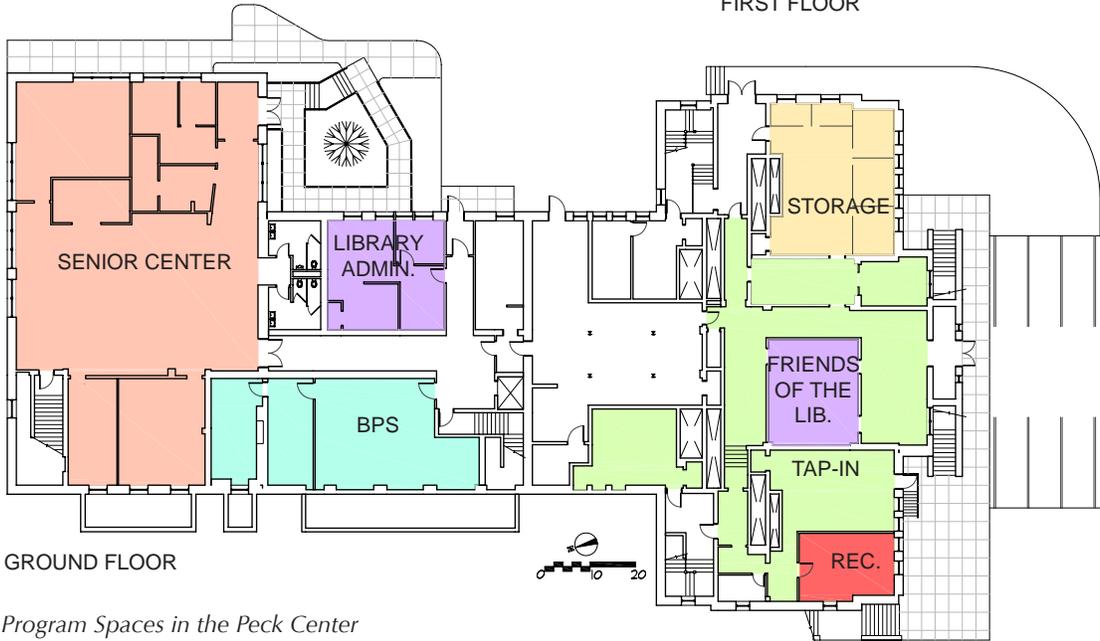
Program Spaces in the Peck Center

The Historic Peck Center is a focal point of community activity in Barrington. The 3-story, 47,000 sf building houses several community based organizations and services including the Barrington Public Library, the Barrington Senior Center, the Recreation Department, the Barrington Preservation Society, and Tap-In. Also, the building provides community spaces including meeting rooms, an auditorium, and storage. While the Peck Center serves a broad range of the population, there are minimal opportunities to engage youth and teenagers. Also, spaces utilized by the Library, Preservation Society and Senior Center are in need of renovations. These organizations also require areas for expansion, which is limited by the current building configuration and parking potential.

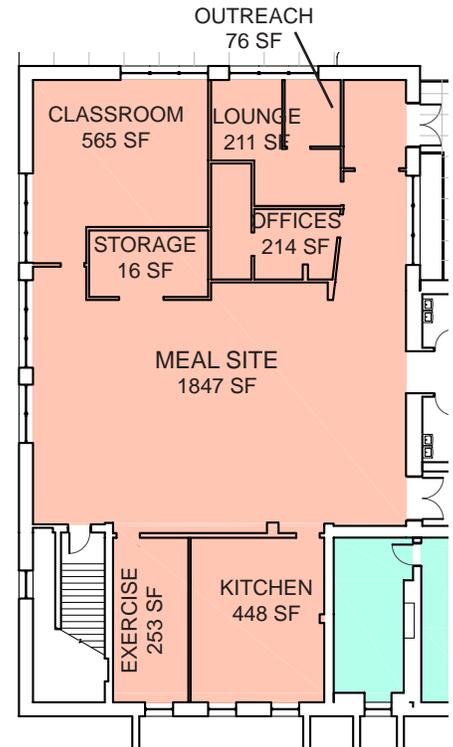
*Senior Center Program Spaces
(Ground Floor)*

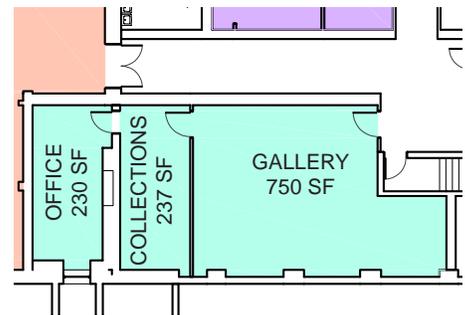
*Preservation Society Program Spaces
(Ground Floor)*

The Barrington Preservation Society presently occupies a portion of the Ground Floor of the Peck Center adjacent to the Senior Center. Spaces include a 750 sf gallery that was recently renovated, a 237 sf collections sorting room, and a 230 sf office. The BPS also has a storage bin in the general storage area adjacent to Tap-In and off-site storage in the Safety Building. The Gallery, which displays a variety of Town artifacts that have mainly been donated by the Barrington community, is open on Tuesdays from 10 am – 2 pm and by appointment. The Preservation Society is also responsible for researching and placarding historic Barrington homes.

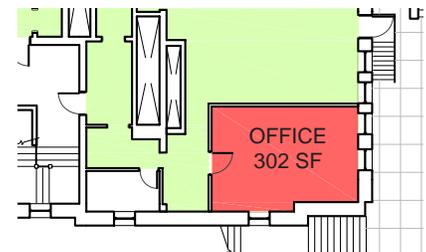
*Recreation Program Space
(Ground Floor)*

The Department of Recreation is currently staffed by a part-time director and an administrative assistant. The 302 sf Recreation Office is located on the ground level of the Peck Center and accessed through TAP-IN via a flight of six stairs which are not universally accessible. Recreation equipment is stored in the area used by TAPIN as a pantry. Local area programs such as Little League and Pop Warner Football operate most of

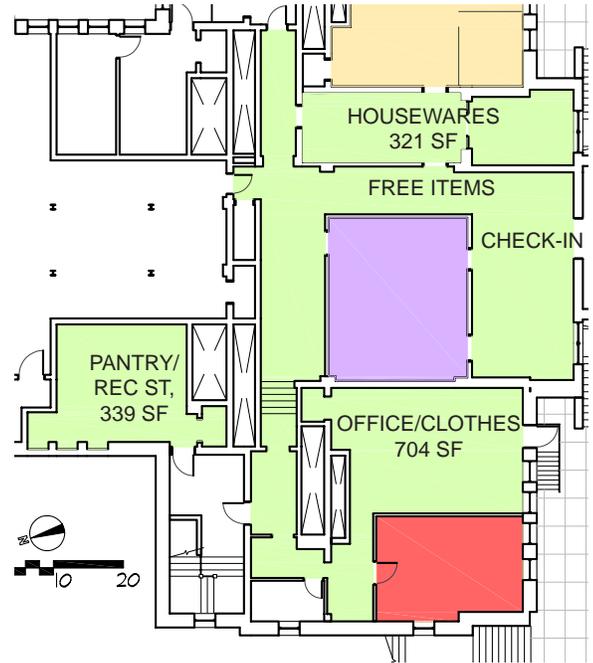
*Tap-In Program Spaces
(Ground Floor)*

Tap-In presently occupies 2,376 sf of space including an administrative room for operational support, consultation and children’s clothing distribution, a food pantry that also serves as storage space for the Recreation Department, and storage/distribution of home goods (Gretchen’s Closet and adjacent storage). Items that are free for the taking are placed in the corridor surrounding the Library Book Sorting Room. Check –in also occurs in this area. The administrative spaces lack confidentiality for consultations with clients. Also, the entire area is not universally accessible as the main entry has an 8” step and the office and pantry areas are accessed via a flight of steep stairs. This poses challenges for users as well as for unloading food deliveries that arrive twice per month.

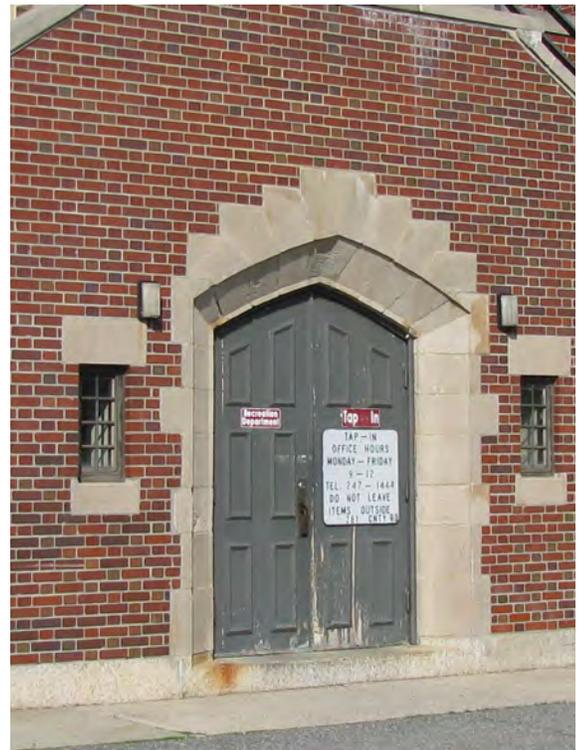
Non-Accessible Tap-In Entry

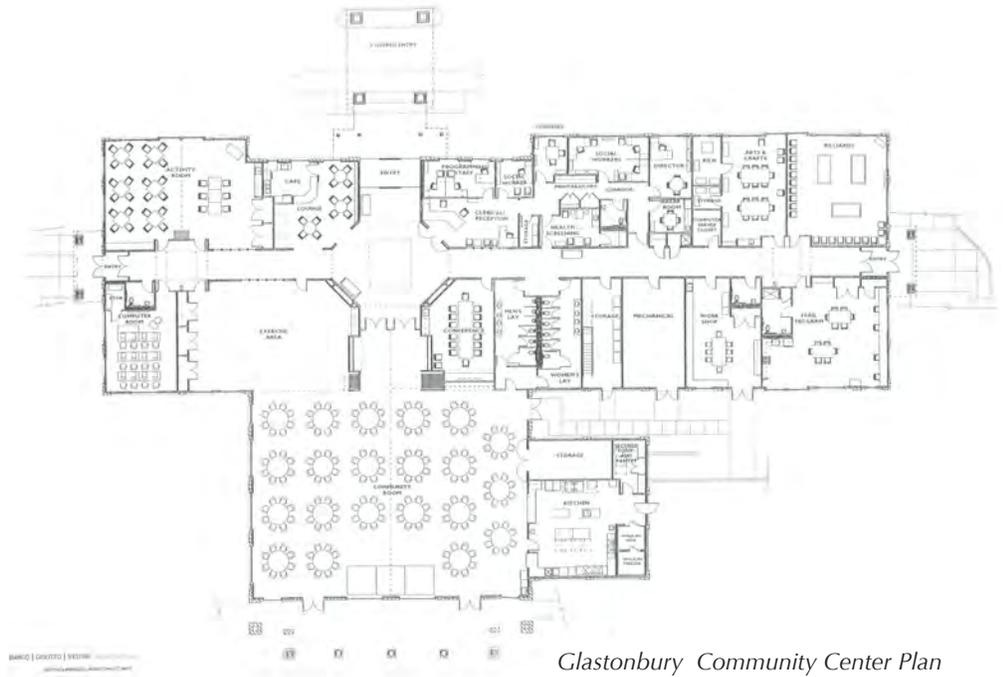
Glastonbury Community Center Plan

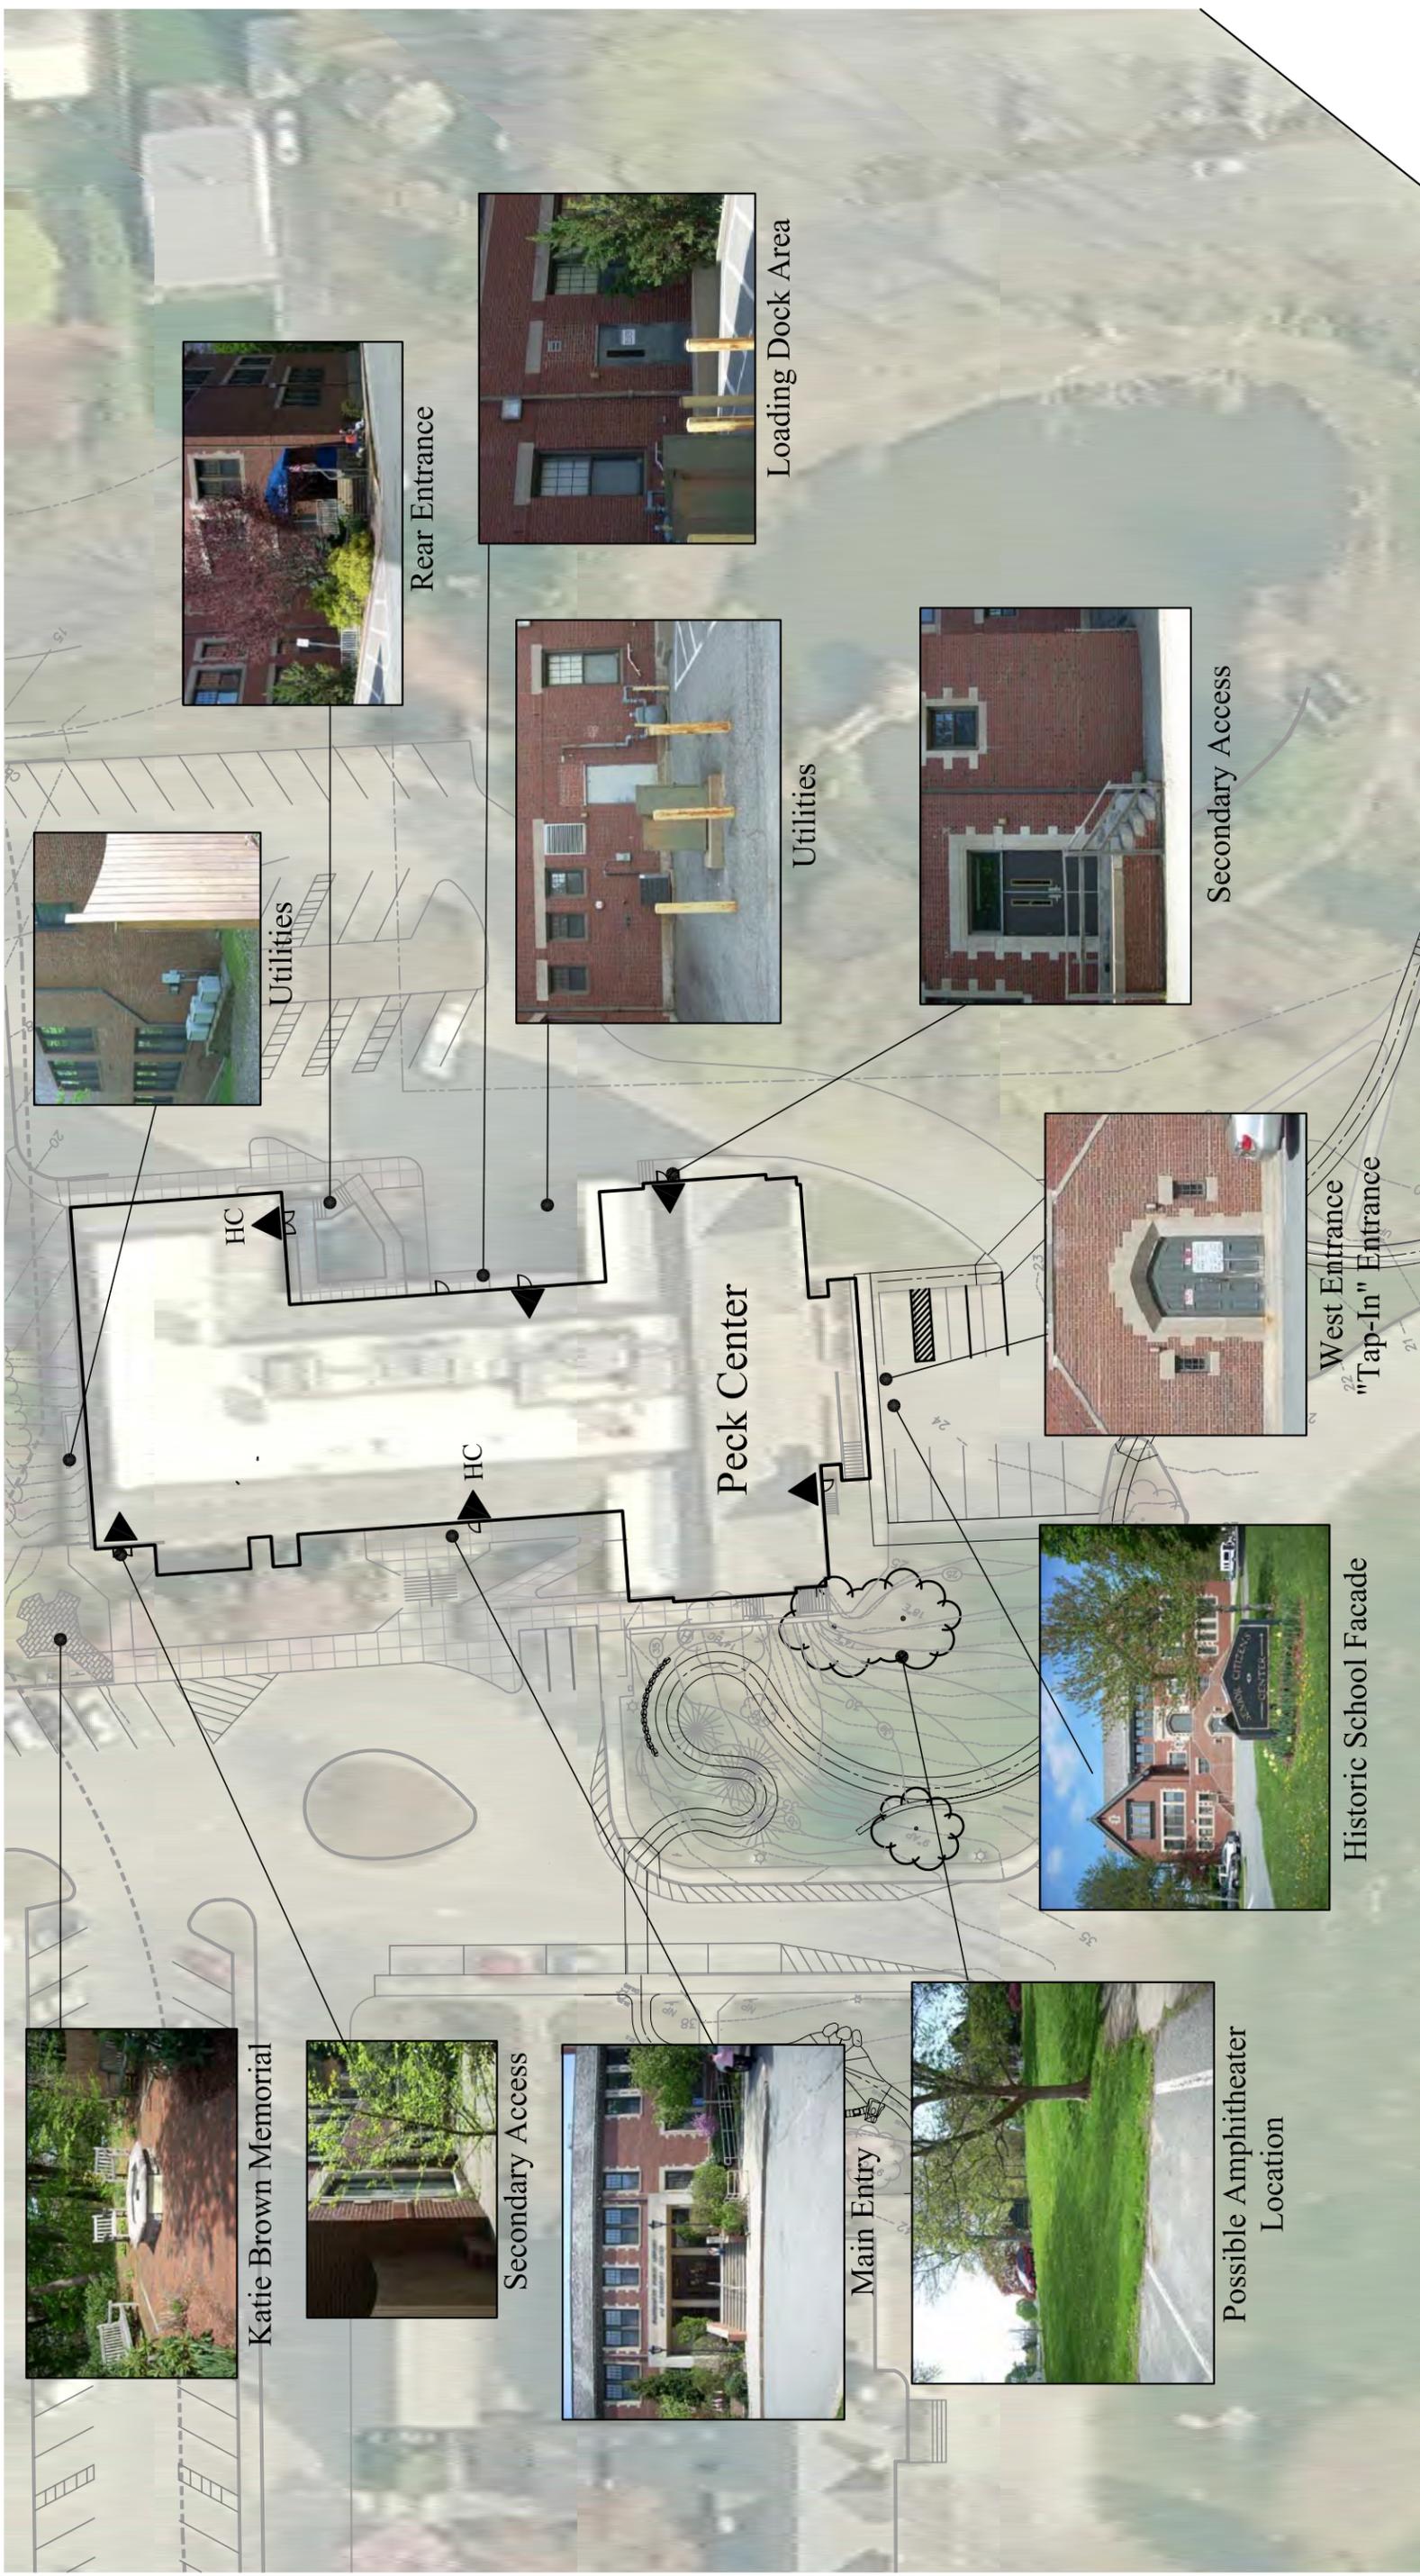
Utilities & Memorial

NOTE:
Diseased trees are to be removed to allow installation of new walk and re-grading of lawn slope.

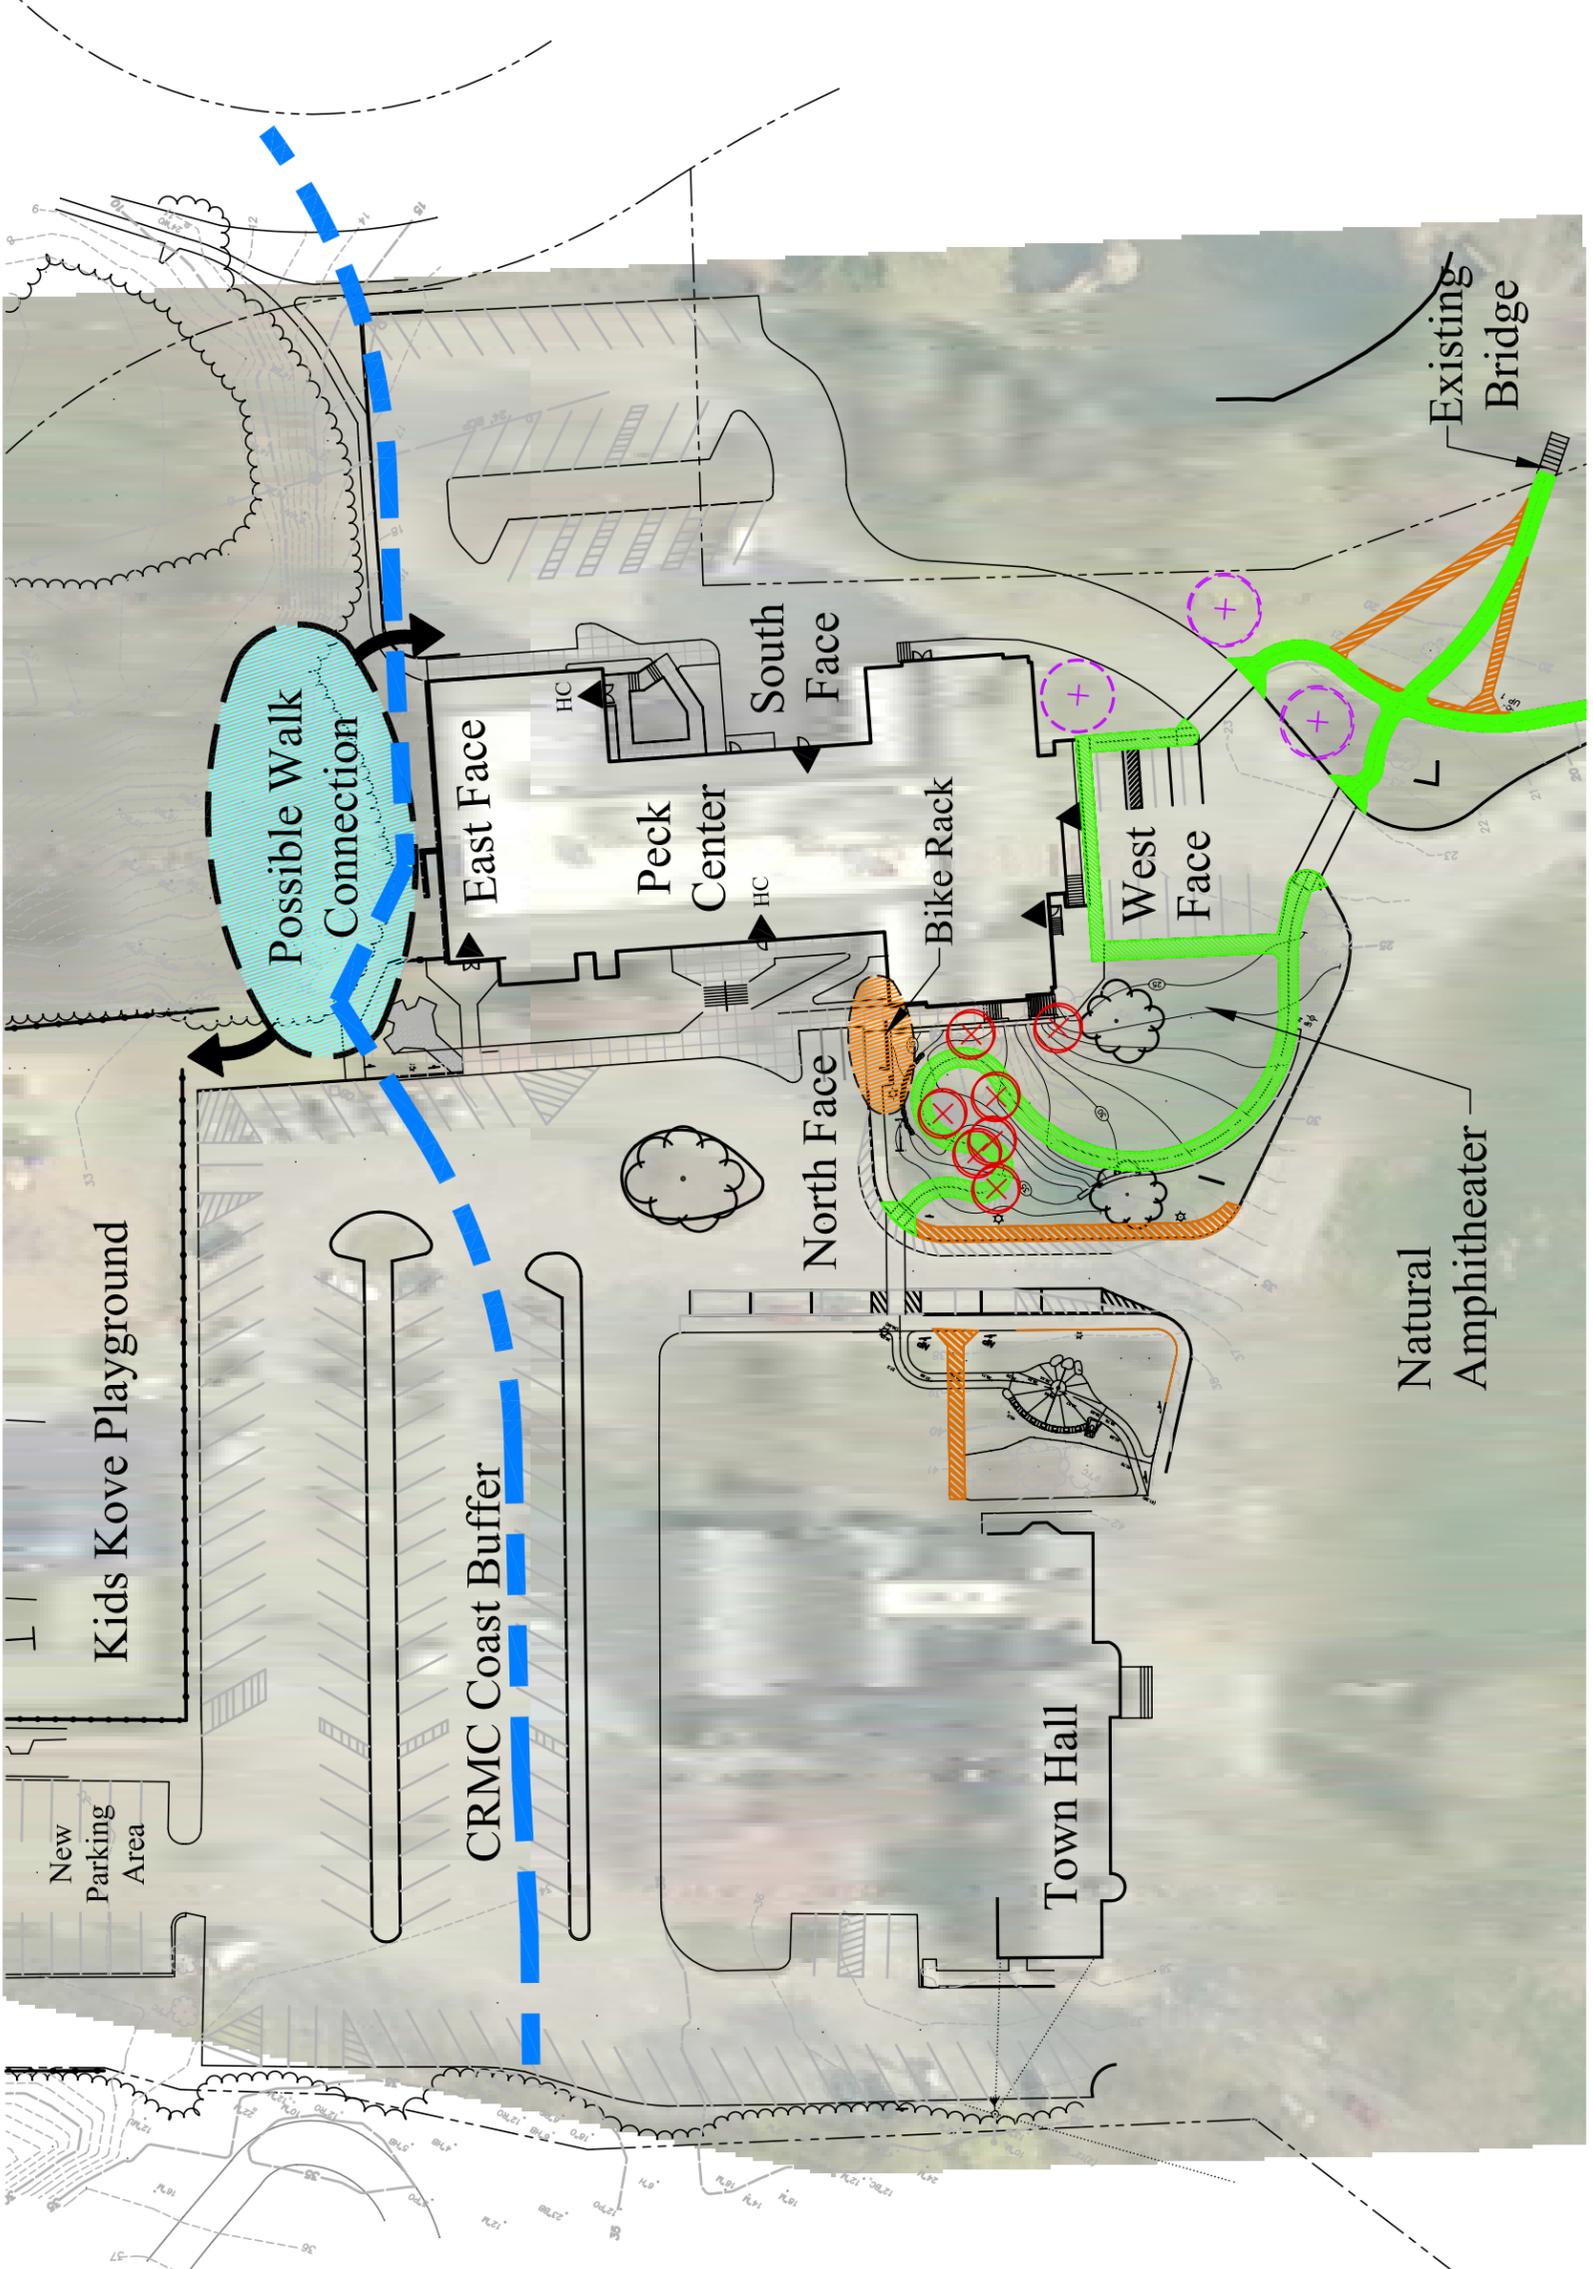
Peck Center Overview Site

Total Parking Spaces	173
Standard Spaces	159
Handicap Spaces	14

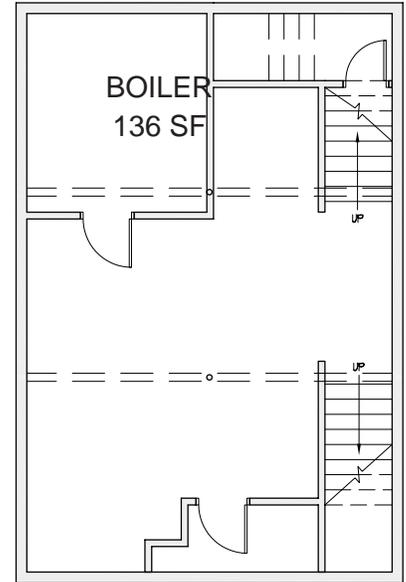
BSCC Existing Basement

The basement contains mechanical equipment and an electrical panel and is accessed from two independent stairways that exit directly outside at the first floor level. A small wood-framed cupola crowns the building and a brick chimney penetrates the roof centered on the east exterior wall. The building is served by a non-compliant municipal fire alarm systems and is equipped with exit signage, pull stations, and strobes.
